**Condition & Compliance Assessment of Lot 102  
Murray Street, Gawler, SA**

**Summary Report**

20<sup>th</sup> January 2026

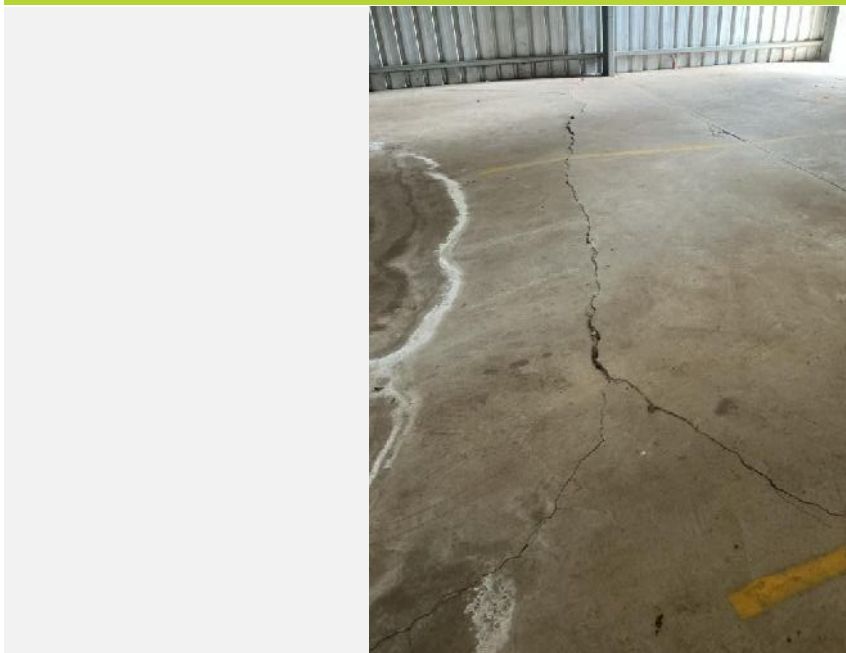
| <b>Location:</b> | Internal |

| <b>Observation on site:</b> | Concrete floor has cracked and uplifted |

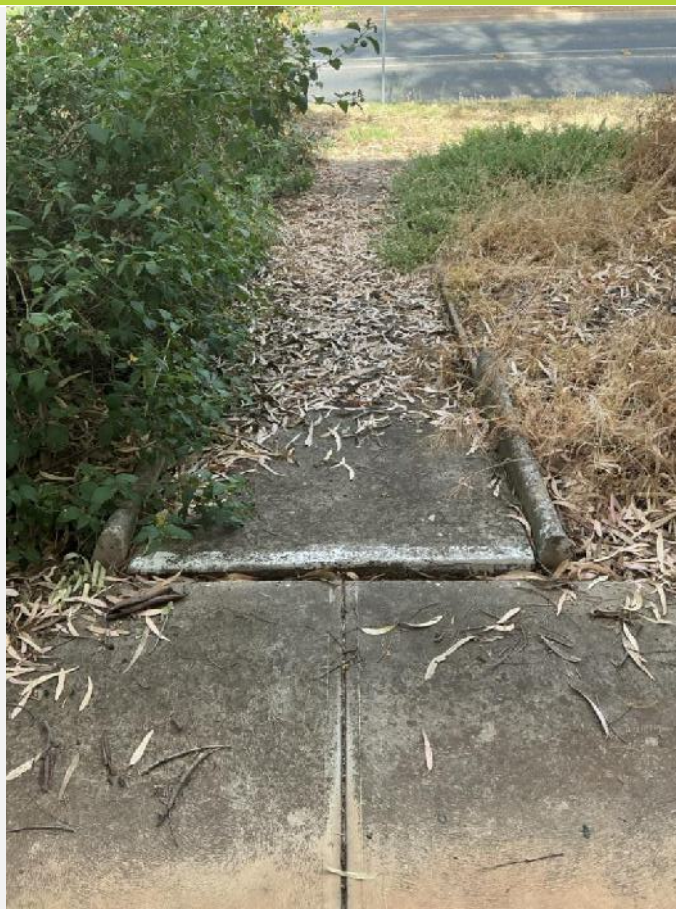
| <b>Location:</b> | External - Footpath |

| <b>Observation on site:</b> | Footpath has experienced uplift – Trip Hazard |
