# Expressions of Interest

## Former Ambulance Station

Portion of Lot 120 Murray Street, Gawler

**Condition & Compliance Assessment of Lot 102  
Murray Street, Gawler, SA**

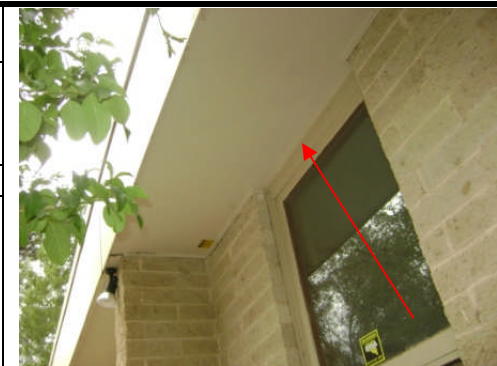
| LOCATION - DESCRIPTION | EXTENT | ASBESTOS ASSESSMENT | CONDITION | SAMPLE NO VISUAL TEST | SIGNAGE STATUS |
|---|---|---|---|---|---|
| B. External, perimeter of building, fascia panel lining – fibre cement sheet. | Approx 400m <sup>2</sup><br>Accessible | Chrysotile asbestos detected | Good<br>Sealed<br>Non friable | 01/WH/240311 | Visible |
| <b>Low Risk P4</b> – Avoid physical and mechanical damage. When maintenance/upgrade is required, recommend removal and reinstate with non-asbestos product.<br><b>August 2011 note:</b> additional warning signage applied to raised roof section at time of re-audit. | | | | | |

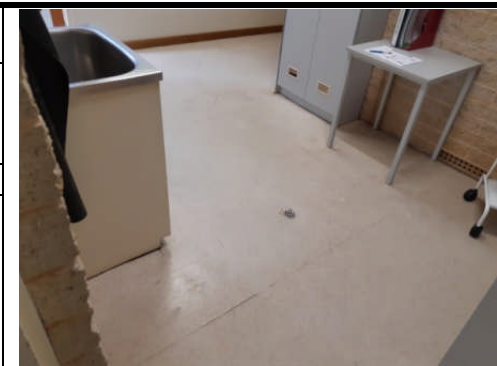
| LOCATION - DESCRIPTION | EXTENT | ASBESTOS ASSESSMENT | CONDITION | SAMPLE NO VISUAL TEST | SIGNAGE STATUS |
|---|---|---|---|---|---|
| 1b. Internal, main (original) building corridor, floor covering mosaic tile pattern (light brown cream colour) – sheet vinyl (lino) backing material. | Approx 20m <sup>2</sup><br>Limited access | Chrysotile asbestos detected | Moderate<br>Sealed<br>Friable | Sample no. 2 of 4 (2/08) | Visible |

Additionally, product deemed safe if friable backing material 'sealed' by vinyl top-layer. For future reference; any lifting, split or damaged areas to be 'sealed'.

**October 2020:** Vinyl sheet floor lining lifting in x3 locations adjacent the main entry door, the main lobby and adjacent kitchen. **Recommend make safe (seal) flooring with silicone or adhesive to prevent further damage. Consider removal of product.**

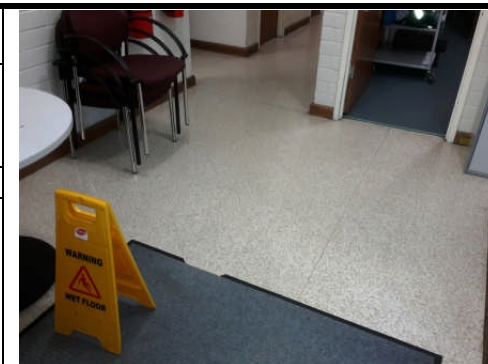
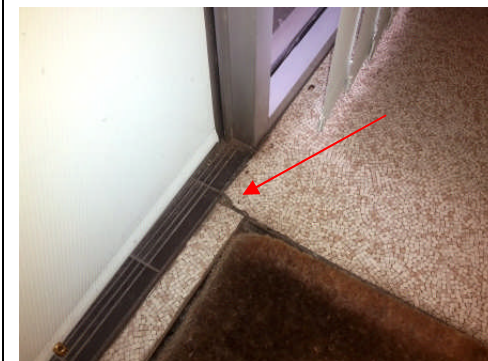
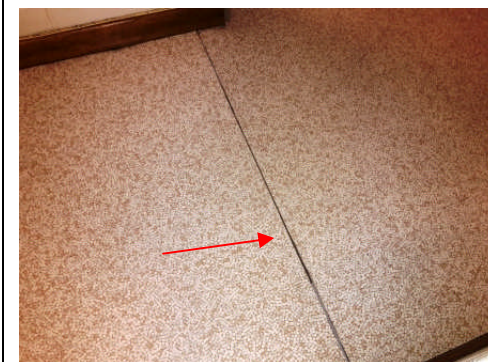
| LOCATION - DESCRIPTION | EXTENT | ASBESTOS ASSESSMENT | CONDITION | SAMPLE NO VISUAL TEST | SIGNAGE STATUS |
|---|---|---|---|---|---|
| 2. Internal, kitchen, floor covering - vinyl tiles (beige colour with light and dark flecks). | Approx 10m <sup>2</sup><br>Accessible | Chrysotile asbestos detected | Good<br>Sealed<br>Non friable | Sample no. 2<br>(05 / 2007) | Visible |

| LOCATION - DESCRIPTION | EXTENT | ASBESTOS ASSESSMENT | CONDITION | SAMPLE NO VISUAL TEST | SIGNAGE STATUS |
|---|---|---|---|---|---|
| <b>Low Risk P4</b> – Avoid physical and mechanical damage. When maintenance/upgrade is required, recommend removal and reinstate with non-asbestos product. | | | | | |

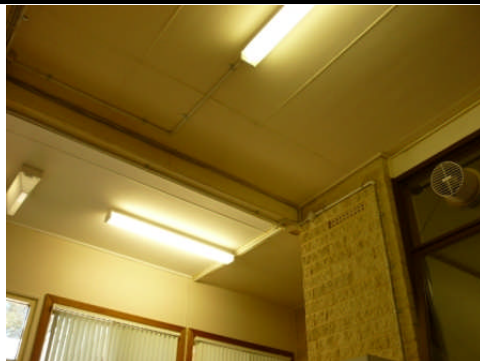
| LOCATION - DESCRIPTION | EXTENT | ASBESTOS ASSESSMENT | CONDITION | SAMPLE NO VISUAL TEST | SIGNAGE STATUS |
|---|---|---|---|---|---|
| 3a. Internal, ambulance bay, ceiling lining – fibre cement sheet. | Approx 100m <sup>2</sup><br>Accessible | Chrysotile asbestos detected | Good<br>Sealed<br>Non friable | 01/WH/210612 | Visible |
| <b>Low Risk P4</b> – Avoid physical and mechanical damage. When maintenance/upgrade is required, recommend removal and reinstate with non-asbestos product. | | | | | |

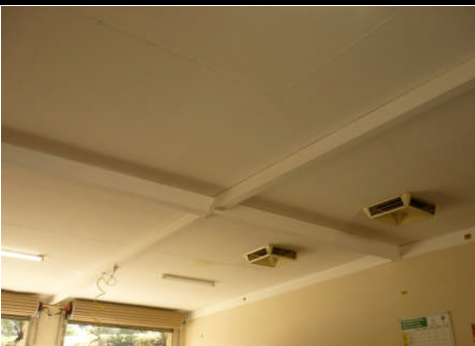
| LOCATION - DESCRIPTION | EXTENT | ASBESTOS ASSESSMENT | CONDITION | SAMPLE NO VISUAL TEST | SIGNAGE STATUS |
|---|---|---|---|---|---|
| 3b. Internal, to crew room / office and associated store, above suspended plasterboard tiles, ceiling lining – fibre cement sheet. | Approx 75m <sup>2</sup><br>Accessible | Chrysotile asbestos detected | Good<br>Sealed<br>Non friable | Representative of sample 01/WH/210612 | Visible |
| <b>Low Risk P4</b> – Avoid physical and mechanical damage. When maintenance/upgrade is required, recommend removal and reinstate with non-asbestos product. | | | | | |

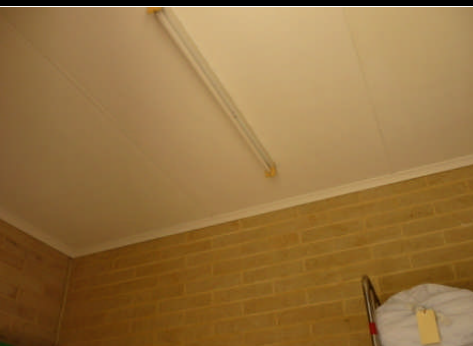
| LOCATION - DESCRIPTION | EXTENT | ASBESTOS ASSESSMENT | CONDITION | SAMPLE NO VISUAL TEST | SIGNAGE STATUS | |
|---|---|---|---|---|---|---|
| 4. Internal, spare ( cleaners ) store, ceiling lining – fibre cement sheet. | Approx 8m <sup>2</sup><br>Accessible | No asbestos detected | - | 02/WH/210612 | - | |

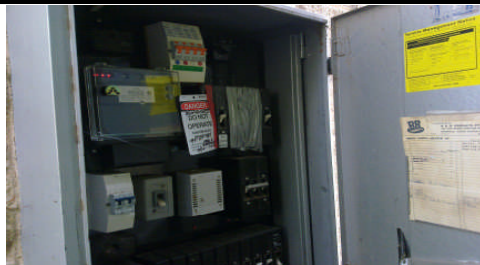
| LOCATION - DESCRIPTION | EXTENT | ASBESTOS ASSESSMENT | CONDITION | SAMPLE NO VISUAL TEST | SIGNAGE STATUS | |
|---|---|---|---|---|---|---|
| F External, south-west corner of building, electrical board – black resin board. | - | - | - | Visual | Not required | |
| <b>August 2011 note:</b> upon close inspection, backing board found to be Bakelite in content.<br>No further requirement to inspect item. | | | | | | |

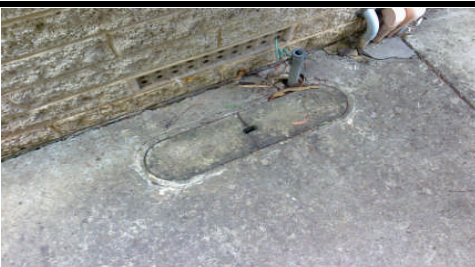
| LOCATION - DESCRIPTION | EXTENT | ASBESTOS ASSESSMENT | CONDITION | SAMPLE NO VISUAL TEST | SIGNAGE STATUS | |
|---|---|---|---|---|---|---|
| G External, south-west corner of building, 'Telstra' communication pit, rim only – moulded fibre cement product. | - | - | - | Visual | Not required | |

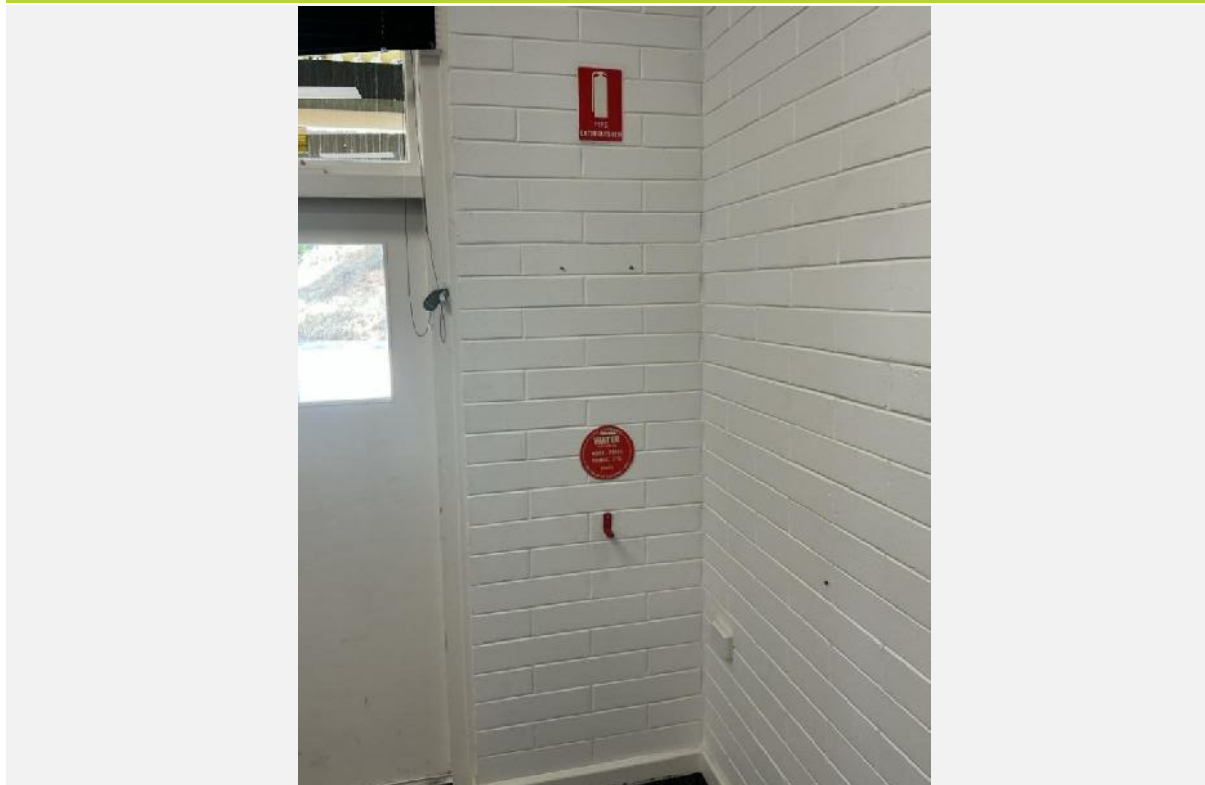
**Location:** Main Hall

**Observation on site:** Fire extinguisher is missing

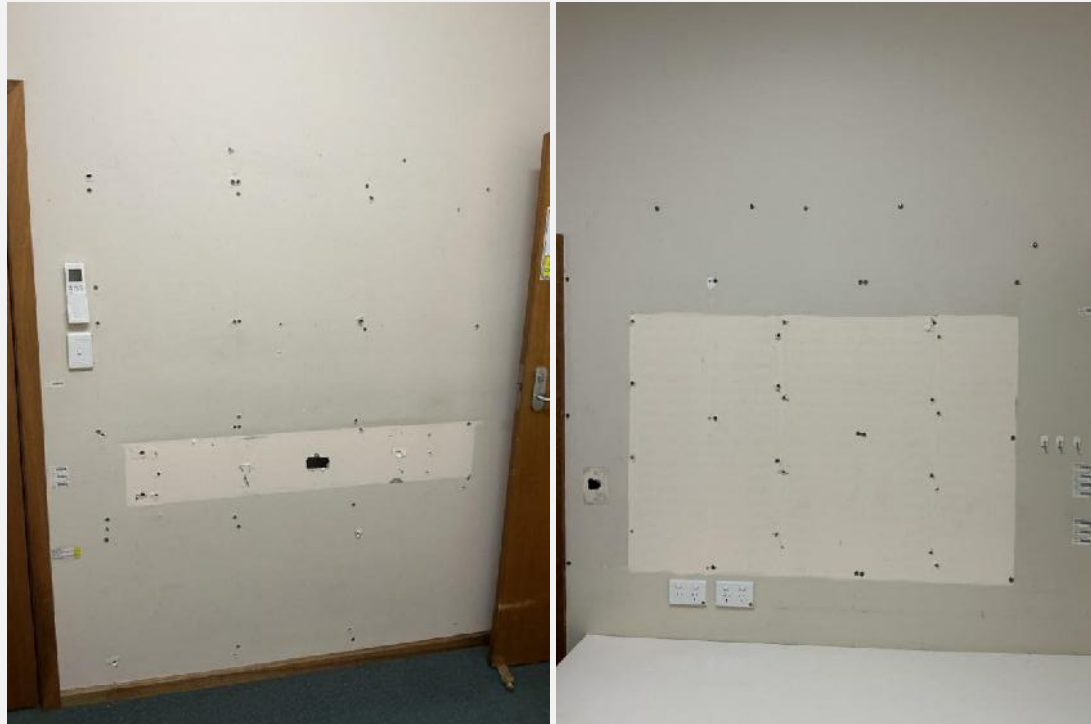
| <b>Location:</b> | Storeroom 1 |

| <b>Observation on site:</b> | Numerous holes in walls |

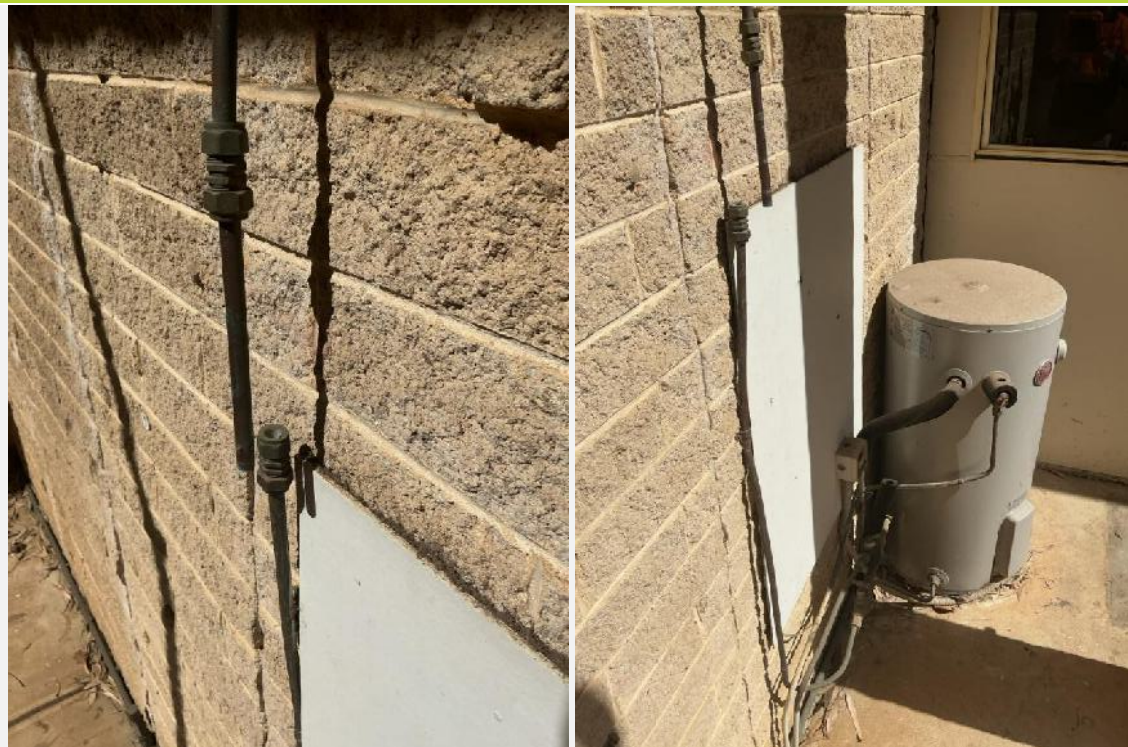
| <b>Location:</b> | External - Plumbing |

| <b>Observation on site:</b> | Copper pipe is disconnected |

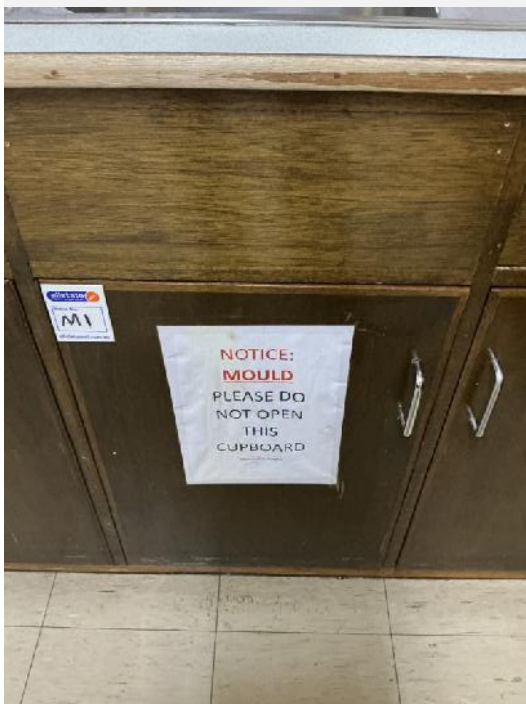
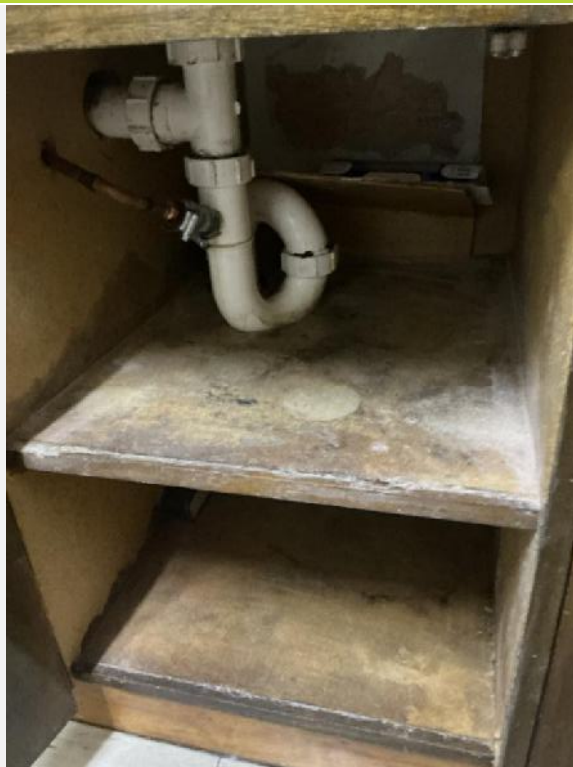
| <b>Location:</b> | Kitchen |

| <b>Observation on site:</b> | Chipping, Damaged, Deterioration, Discolouration, Mould, Stained, Water Damage, Worn |

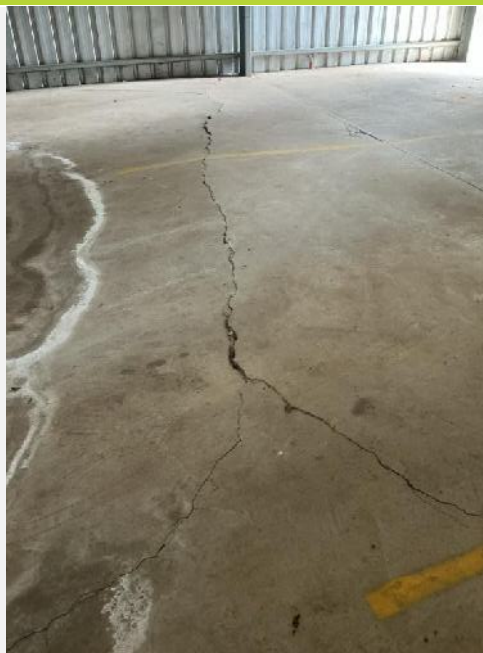
| <b>Location:</b> | Internal |

Tree root damage has been identified to the larger shed. Engineering advice obtained by Council recommends partial replacement of the shed floor.

| <b>Observation on site:</b> | Concrete floor has cracked and uplifted |

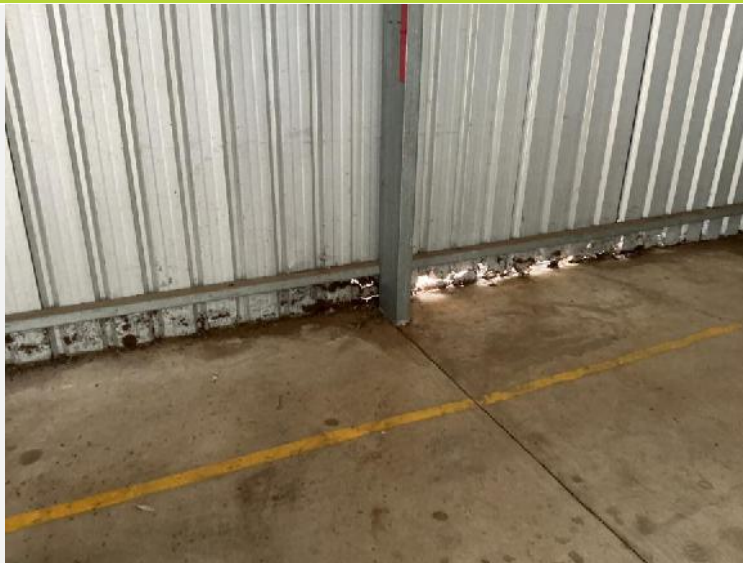
| <b>Location:</b> | External |

| <b>Observation on site:</b> | Shed 1 walls have rusted badly |

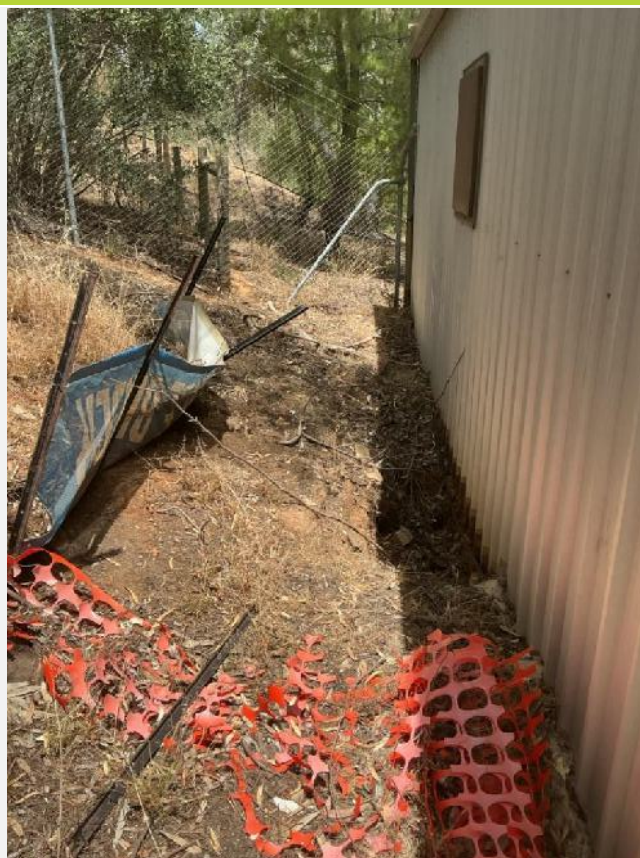
| <b>Location:</b> | External |

| <b>Observation on site:</b> | Large hole dug alongside of shed |

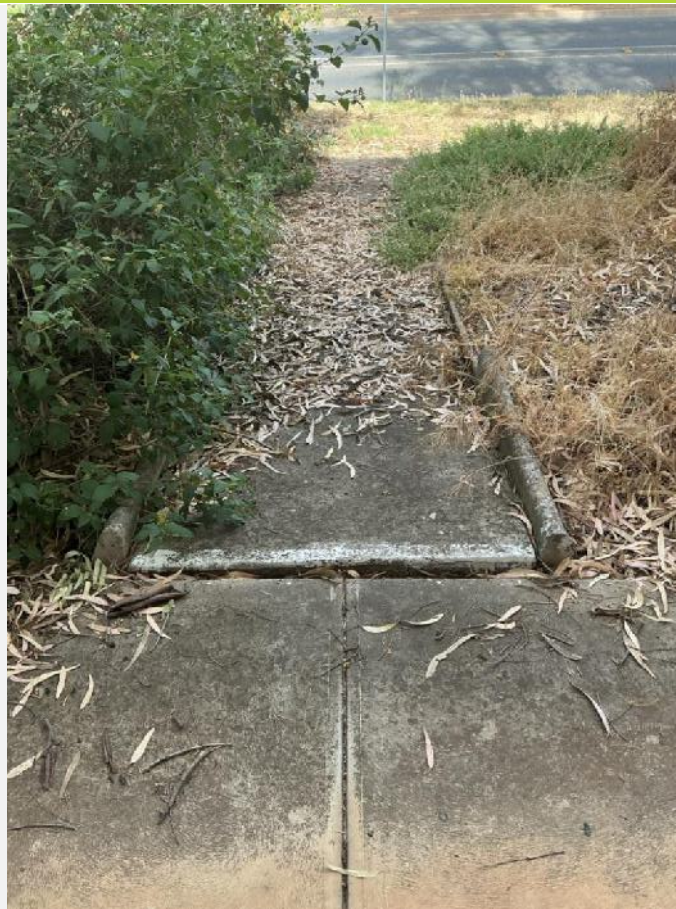
| <b>Location:</b> | External - Footpath |

| <b>Observation on site:</b> | Footpath has experienced uplift – Trip Hazard |
